Inspection Report

Property Address: 1234 Hamilton Ln, Oak Brook IL 60523

Better Value Property Inspections, Inc.

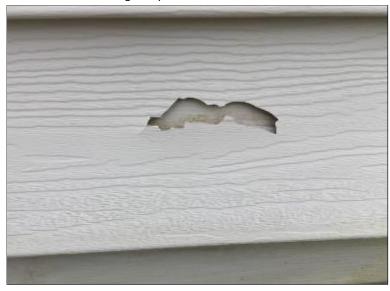
2.0 Picture 1

Repair damaged siding to the front wall. Wall cladding material should be at least eight inches above the grade to protect the cladding system and the structure from water damage. Repair as needed.

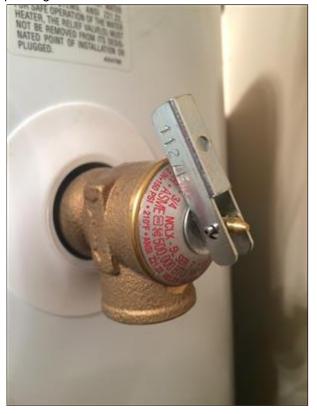
4.2 Picture 1

The temperature/pressure relief valve drain line is missing. This is a safety hazard and indicates a non-professional installation. We recommend a copper or galvanized steel drain line be extended to a safe location as required.
